This spreadsheet performs screening level calculations to estimate the effect of peeling leaded paint on the average concentration of lead in yard soil
3632 Williams St.

Property ID: 415	Date: 8-8-05
Address: 3632 WILLIAMS ST	Telephone #:
Owner:	CO Certification #: 12860
Inspector/Assessor:

LBP Assessments Results

Property ID # 415 / 3632 Williams Street

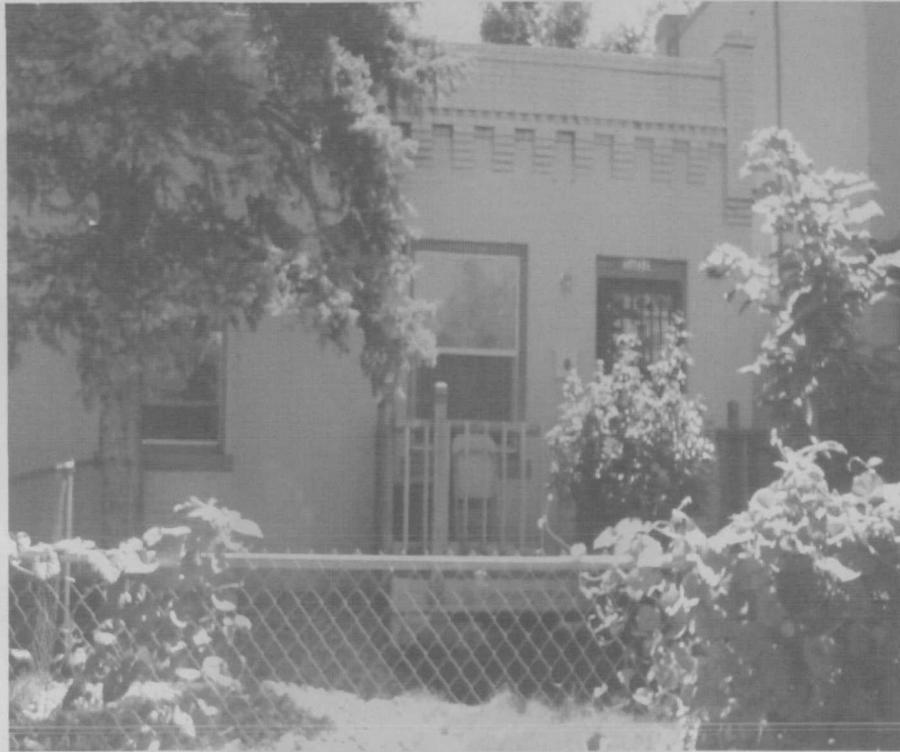
West porch exposure of house

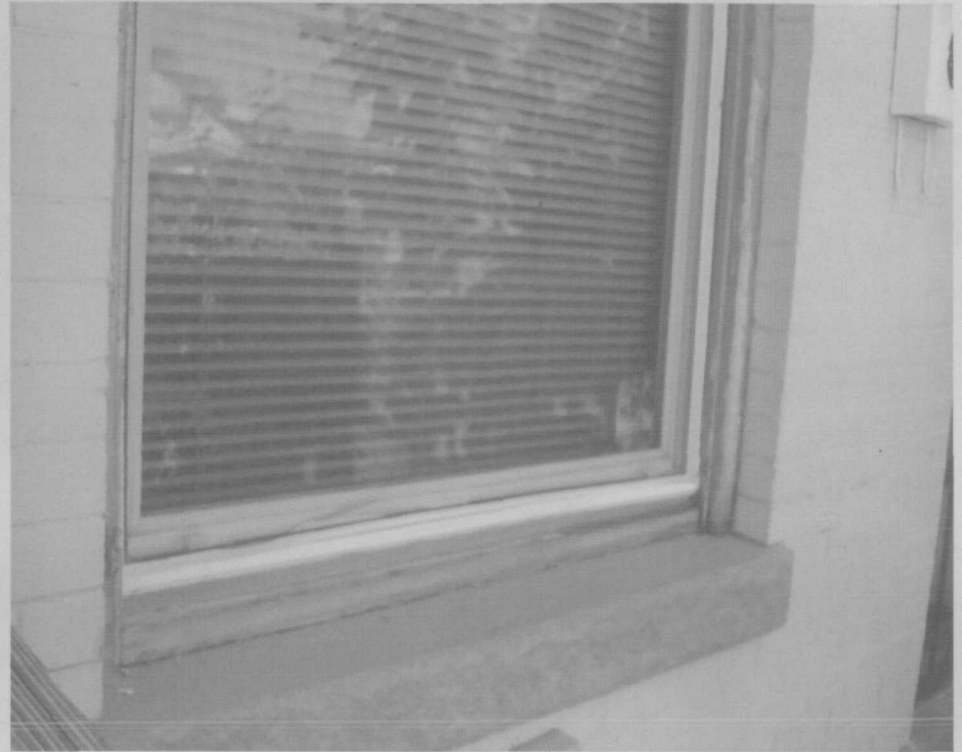
Time	Site	Component	Substrate	Side	Condition	Color	Floor	Room	Results	Depth Ind	PbC	PbC Error
8/8/2005 10:20	415	WINDOW SILL	CONCRETE	WEST	INTACT	BROWN	FIRST	OUTSIDE	Negative	1.65	0.16	0.04
8/8/2005 10:21	415	WINDOW FRAME	WOOD	WEST	CRACKED	BROWN	FIRST	OUTSIDE	Positive	4.61	24.7	1.4
8/8/2005 10:22	415	EXT. WALL	BRICK	WEST	INTACT	TAN	FIRST	OUTSIDE	Negative	3.56	0.02	0.04
8/8/2005 10:23	415	THRESHOLD	CONCRETE	WEST	PEELING	GREY	FIRST	PORCH	Negative	1.16	0.06	0.02
8/8/2005 10:24	415	RISER	WOOD	WEST	PEELING	GREY	FIRST	PORCH	Negative	1	0	0.02
8/8/2005 10:26	415	EXT. WALL	BRICK	WEST	CRACKED	TAN	FIRST	OUTSIDE	Negative	2.02	0.01	0.02
8/8/2005 10:27	415	WINDOW SILL	CONCRETE	SOUTH	CRACKED	BROWN	FIRST	OUTSIDE	Negative	1.31	0.07	0.03
8/8/2005 10:28	415	WINDOW FRAME	CONCRETE	SOUTH	CRACKED	BROWN	FIRST	OUTSIDE	Positive	4.32	11.2	1.3
8/8/2005 10:29	415	EXT. WALL	BRICK	EAST	PEELING	TAN	FIRST	OUTSIDE	Negative	1.93	0.08	0.04

West wood window sill contains peeling lead paint

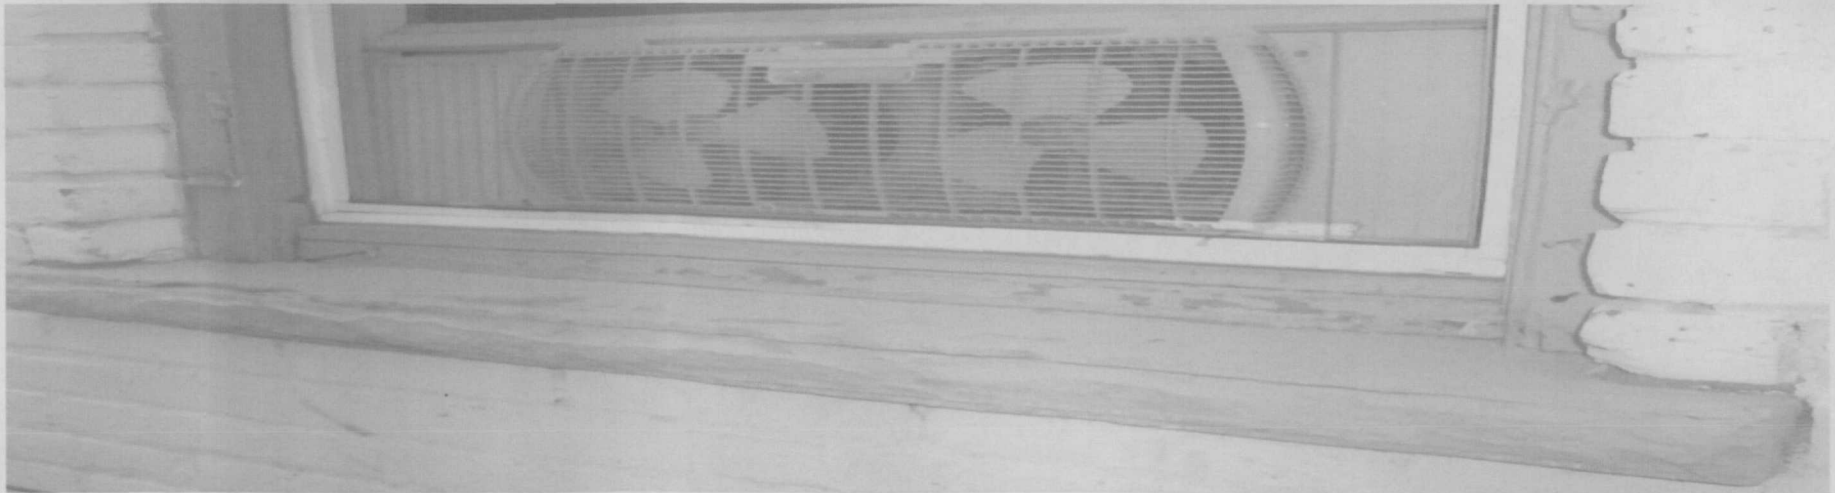
South wood window frame contains peeling lead paint
